CNA Insurance Saves Clients More Than \$105m in Risks and Losses

— Infrared Surveys Now a Standard Practice

By Thomas A. Gray, PE, FSPFE, ABCP
 Certified Level II Infrared Thermographer
 Consulting Director, Property Risk Control
 CNA Insurance - Chicago IL

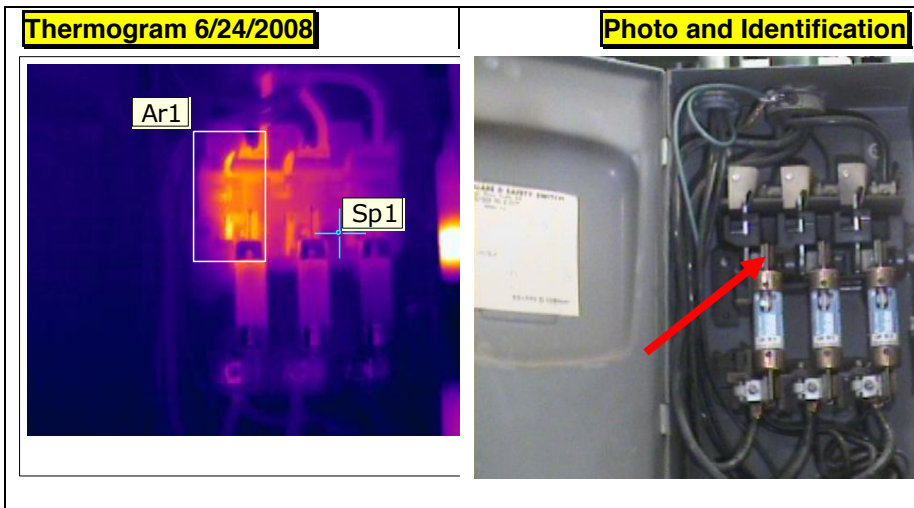
This represents an Intermediate fault. This fault should be corrected by a qualified electrician within 60 days. Correction of this fault also represents potential energy savings of \$100 per year.

The A phase fuse knife connection (Ar1) is significantly hotter than the other connections (Sp1). This knife connection should be removed and the conductor connections inspected for corrosion/pitting or other faults. If corrosion/pitting or other faults are found, then the knife connection should be replaced.

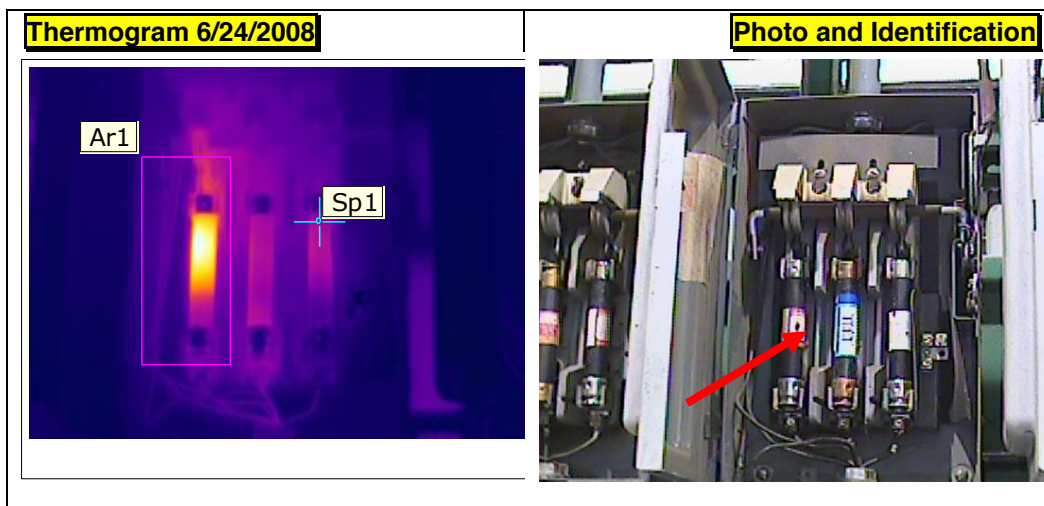
This represents a Serious fault based on the apparent temperature differential compared to similar equipment in the panel. This could result in the failure of the circuit breaker and ultimately an electrical fire loss of \$250,000 or more. This fault should be corrected by a qualified electrician within 30 days. Correction of this fault also represents potential energy savings of \$187.50 per year. This fault is not likely to result in a business interruption loss from the circuit failing due to the circuit controlling just lighting.

This circuit controls shop lighting. While heating of these fuses is typical due to the lights being under load continually, the level of heating in the A phase fuse (Ar1) was noted to be excessive. The fuse itself may be deteriorating internally and should be replaced.
